Ingersoll

TIMELY TIPS

1974 - 1979

Service Manual 9-51610

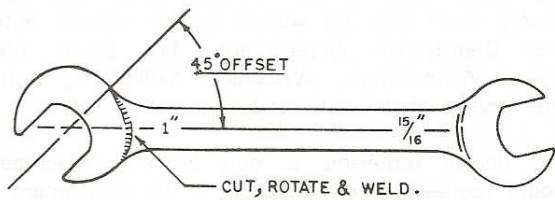
When vibration isolation mounts were added to 10, 12 and 14 H.P. compact tractors, we changed the steel tube between the pump and travel control valve to a wire braid hose. The hose does not permit the use of a tube wrench and the hose swivel at the valve inlet fitting is not easily accessible with a standard open end wrench.

By modifying a standard 1" open end wrench as illustrated, you can R & R this hose at the valve without interference from the tractor frame rail.

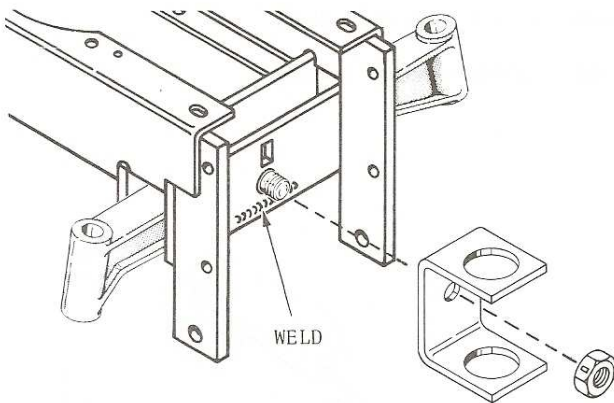
The drive belt on some Model K41 mowers can come off during operation. The belt may be loose and/or misaligned. The following checks are recommended when predelivering or performing routine service on Model K41 mowers.

Remove the PTO housing and place a weld bead or weld the appropriate size key stock across the lower front face of the front axle support to correct this condition. The weld bead must be just high enough to "shim" the PTO housing to a vertical position. The PTO housing must be vertical front-to-rear and side-to-side after it is reinstalled. See Figure below.

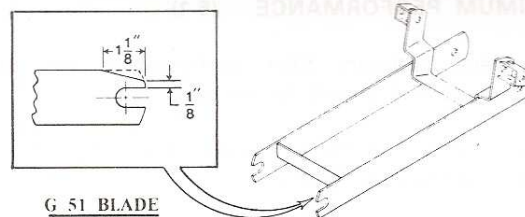
G 51 BLADE

When mounting G51 Blades, G81 or J81 Snow casters, below these serial numbers or which were shipped from the factory prior to November 22, 1974, or 1975 Model 108 tractors, the mounting bracket must be cut or ground off as illustrated. Also remove sharp edges and check for adequate pulley and belt clearance following installation.

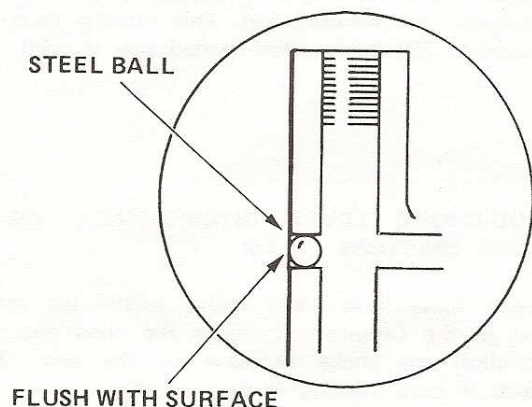
If excessive amounts of engine oil are carried over into the carburetor through the crankcase breather, a lack of crankcase vacuum is indicated.

The hole location for this ball is at the 3 o'clock position from the cam opening. See illustration below.

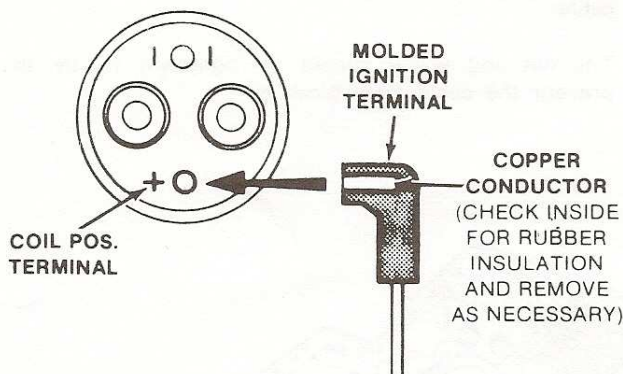
The molding process of this connector may allow insulation to flow inside the connector creating the symptom of a defective coil. See illustration for details.
