May 31, 1978

TIMELY OPE TIPS FOR THE MONTH

ISSUE # 51

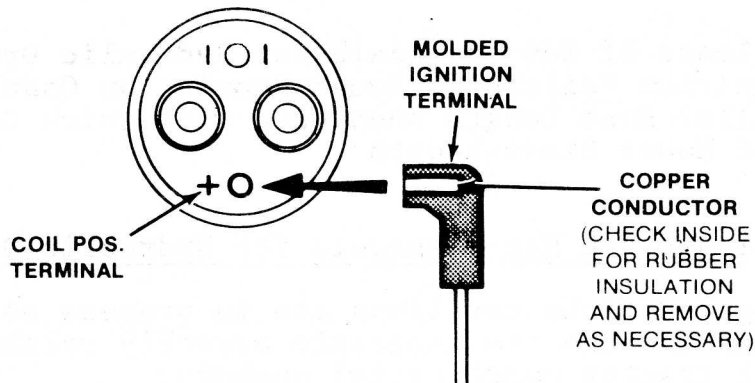
There has been an increase in warranty claims recently for Onan engine ignition coils P/N C20349. When these coils are returned to Onan and tested; they check OK.

The push-on connector for the positive and/or negative coil terminal should be checked to be certain they are free of any insulation on the inside of the connector and that they fit tight on the coil terminals.

The molding process of this connector may allow insulation to flow inside the connector creating the symptom of a defective coil. See illustration for details.

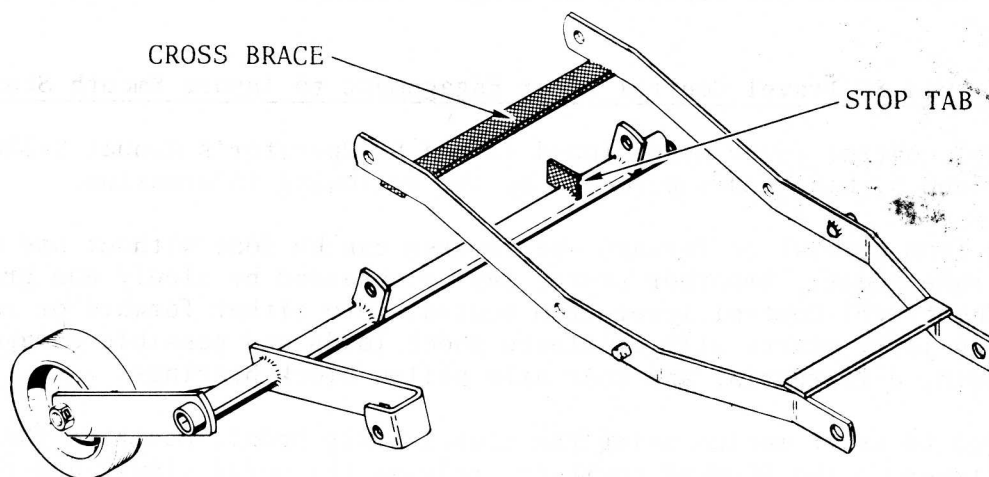
If the deck does not remain level when put in the 2" and 1-1/2" settings, check for contact between the stop tab on the gauge wheel axle and the flat cross brace on the mounting frame. Remove or reduce the tab, if required, to prevent any contact.

If the tab is not contacting the cross brace, make leveling adjustments at the "J" bolts as described in the mower operator's manual.

Mowers currently leaving the factory are being double checked in this area. The cross brace is now located between rather than below the two longitudinal members.

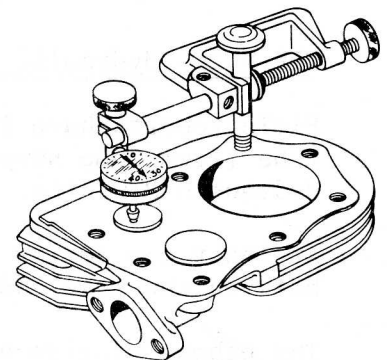
NOTE: Caution must be exercised in the bending of the tab as it is hardened and may crack or break if bent back and forth more than 3 or 4 times.

STEP 5: If the valve lift was above .042"(1.06 mm), hold a wooden dowel on the top of the valve and tap it down carefully to within the .031"(.79 mm) - .042"(1.06 mm) range. If the valve lift was below .031"(.79 mm), remove the camshaft cover on the side of the engine exposing the cam gear and bend the ACR tab carefully upward until the valve lift is within the specified range.

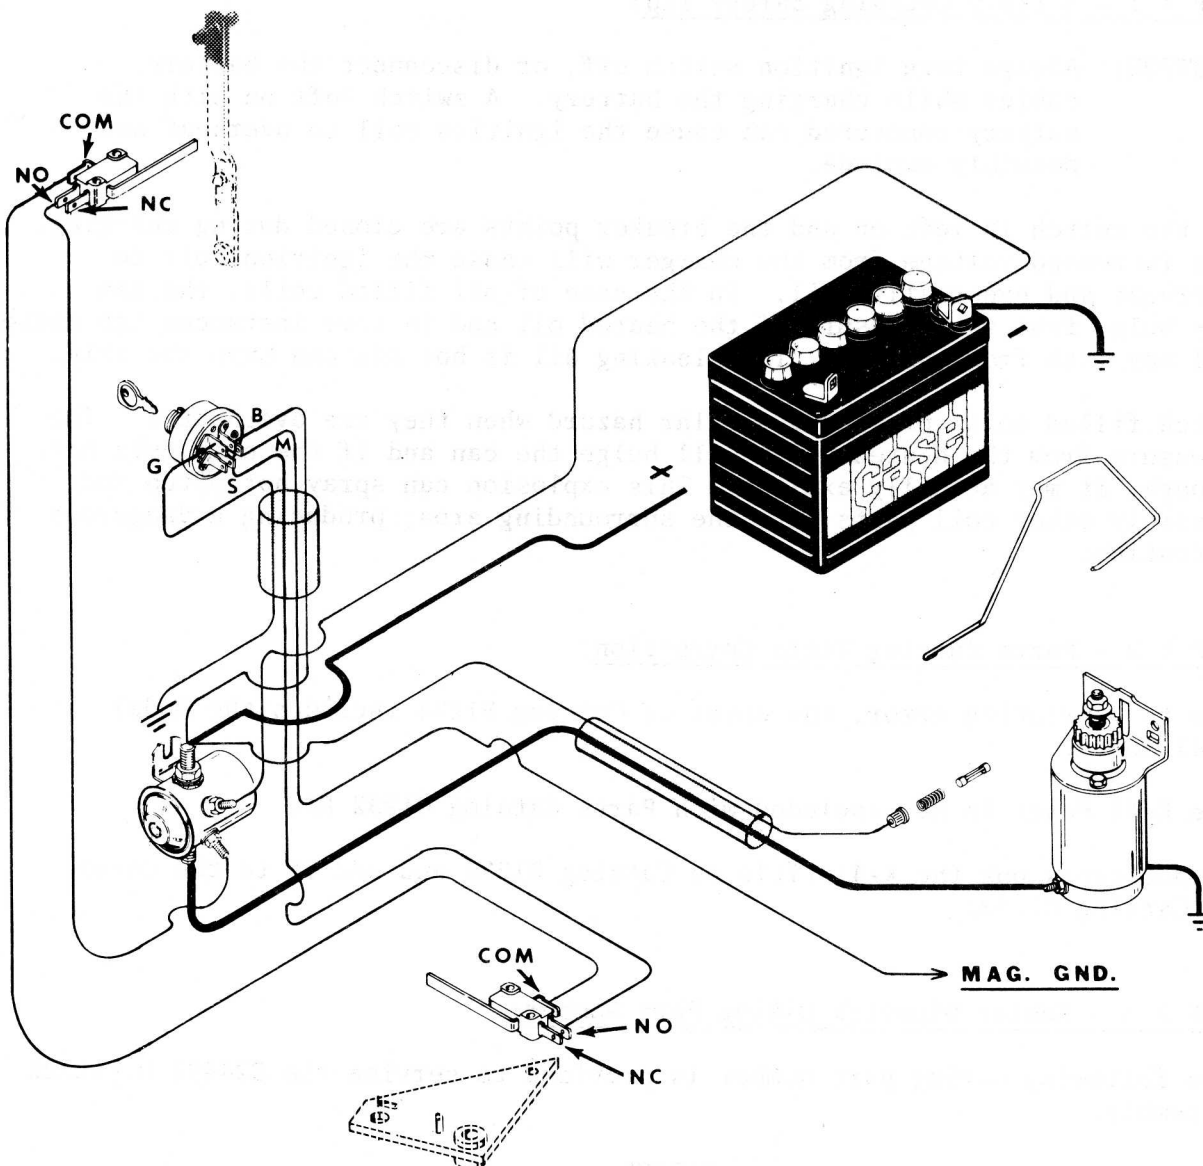
The Model 108 tractor neutral start circuitry was changed beginning with S/N 9747008. The neutral start switches are wired in series on the positive (+) side of the starter solenoid. A grounding wire is connected from the second solenoid small terminal directly to ground.

See the accompanying wiring diagram.

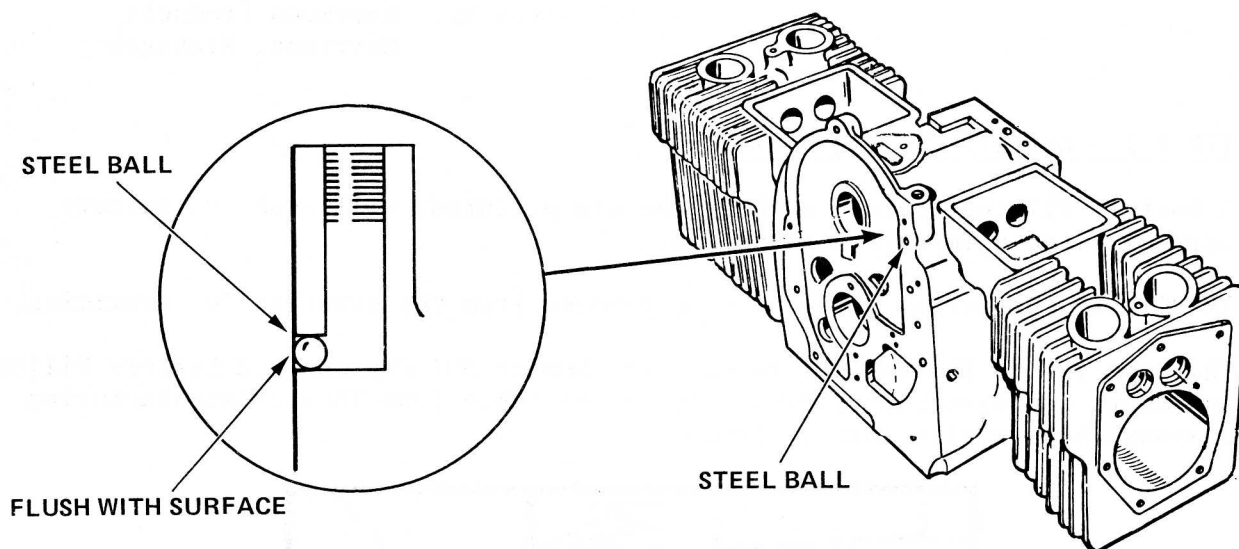
Another cause of this problem found in the Onan Model BF or B43 (both used in Model 446 tractors) may be the absence of the oil by-pass plug.

This ball must be driven flush to the block surface. If driven too deep it will hold the oil pressure valve open causing low oil pressure. If not driven deep enough the gearcase cover will not seal properly. Use a hammer to properly seat the ball.

The hole location for this ball is at the 3 o'clock position from the cam opening. See illustration below.

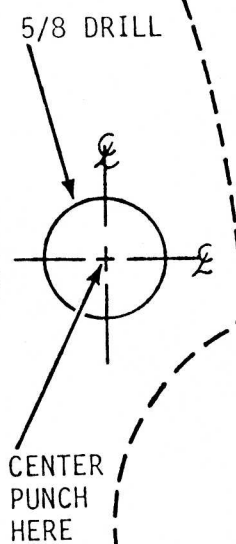
TEMPLATE FOR LOCATING TIMING
SIGHT HOLE (J.I. CASE)

The timing sight hole for Kohler engines to be used with a starter-generator must be on the left edge of the front bearing plate.

1. Cut along dotted line.
2. Set template on bearing plate.
3. Center punch hole location.
4. Drill 5/8" hole in plate.

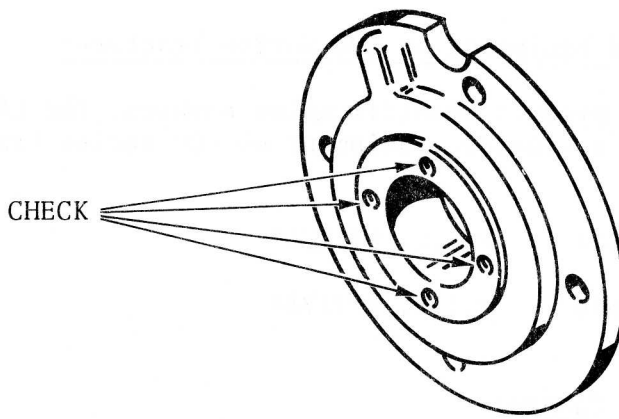
TIP # 5 - Engine Oil Leak at Rear of Crankshaft Model 446 Tractor:

The four small screw holes in the rear main bearing carrier should be inspected for oil leaks before replacing the rear main seal.

Several units have been reported to have the screw hole drilled too deep and into an oil passage.

To stop the leak, apply thread sealer to a 1/2 inch long 10-32 screw and install the screw in the leaking hole.

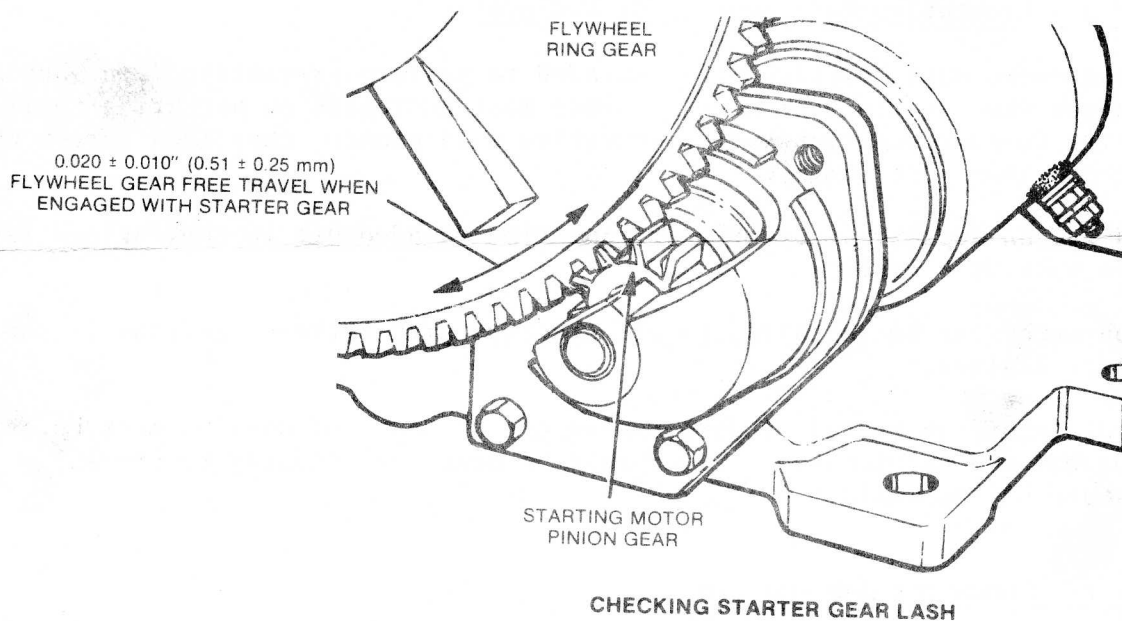
All Onan twin cylinder engines allow for repositioning of the starter motor to assure proper gear lash between the starter pinion gear and the flywheel ring gear. If a starter binds or slips during cranking, or is excessively noisy, the gear lash may be incorrect and should be checked. Gear lash should also be checked anytime the starter has been loosened or removed.

1. Install the starter motor and tighten its mounting bolts just enough to hold the starter in place.
2. Remove the spark plugs from the engine to allow free movement of the flywheel. Or, if the flywheel is off of the engine, temporarily mount it on the engine with no key in the crankshaft keyway.
3. Pull the starter pinion gear outward on its shaft so that its teeth mesh fully with those on the flywheel.
4. Measure the amount of free travel, or lash, between the pinion gear teeth and the ring gear teeth, as shown in the figure below. The proper lash is 0.020 ± 0.010 (0.51 ± 0.25 mm). Loosen and adjust the starter motor as necessary to obtain the correct setting.
5. Tighten the starter mounting bolts and install the spark plugs.

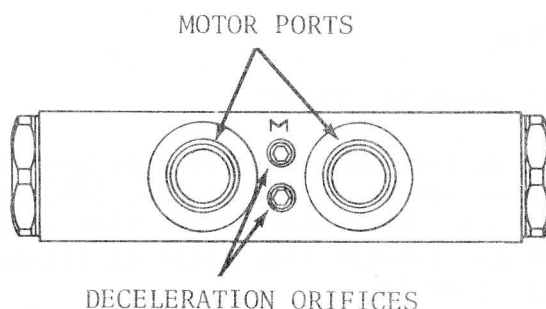
The orifices should be drilled through into the valve bore. If one or both orifices are not drilled through, drill them to .067 inch diameter.

Carefully clean and reassemble the valve.

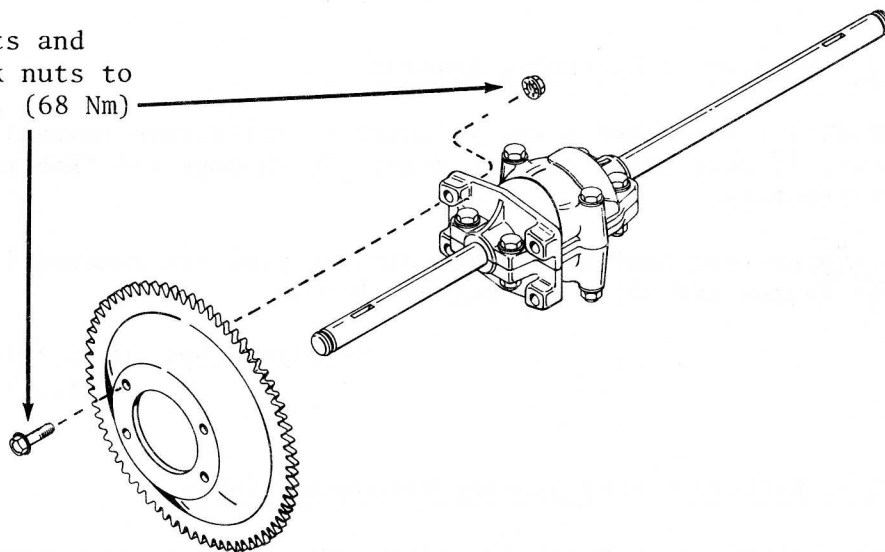
There have been reports indicating the four, P/N 131-911, flange lock nuts on the Model 80 riding mower final drive sprocket have worked loose. Our supplier for this special 5/16" bolt and lock nut specifies a much higher torque specification than is normally given for this size bolt. The correct torque specification for this special bolt and nut is 50 foot pounds (68 Nm).

Torque bolts and
flange lock nuts to
50 ft. lbs. (68 Nm)

Beginning with P.I.N. 9772896 these four bolts and nuts have been torqued to the new specification in production. All Model 80 riding mowers prior to this P.I.N. should have these bolts retorqued either during predelivery or when they are in for routine service. Also, please advise your Model 80 riding mower customers of the new torque specification, and, if they are unable to do so, to bring their mower in to you for the proper bolt tightening. It is important that these bolts and nuts on all Model 80 riding mowers prior to P.I.N. 9772896 are retorqued to the new specification before they receive further use.

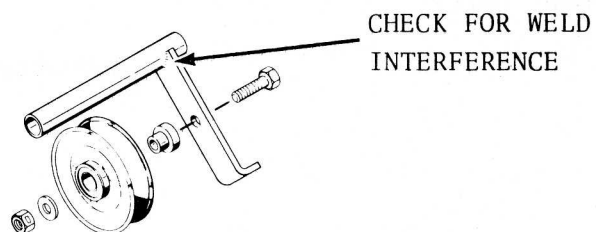
Effective with the following P.I.N. the vee idler pulley, Part Number C10463, was changed to Part Number C25370:

J40 - S/N A59542
J44 - S/N C65190
J46 - S/N D63972
