Repairing an Onan 2-Piece Intake Manifold

by: Craig Myers (craigtone@centurytel.net)

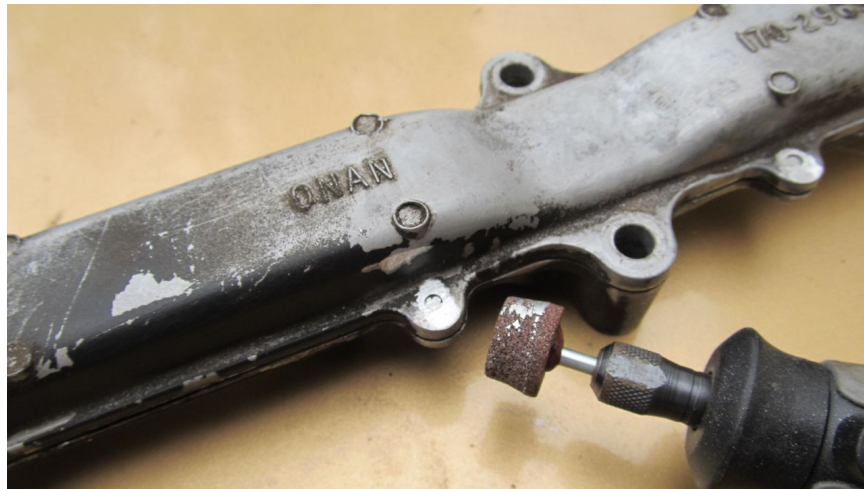
1. Remove the intake manifold from the tractor.
2. Remove the carburetor from the intake manifold.
3. Using a Dremel, grind off the rivets holding the halves together.

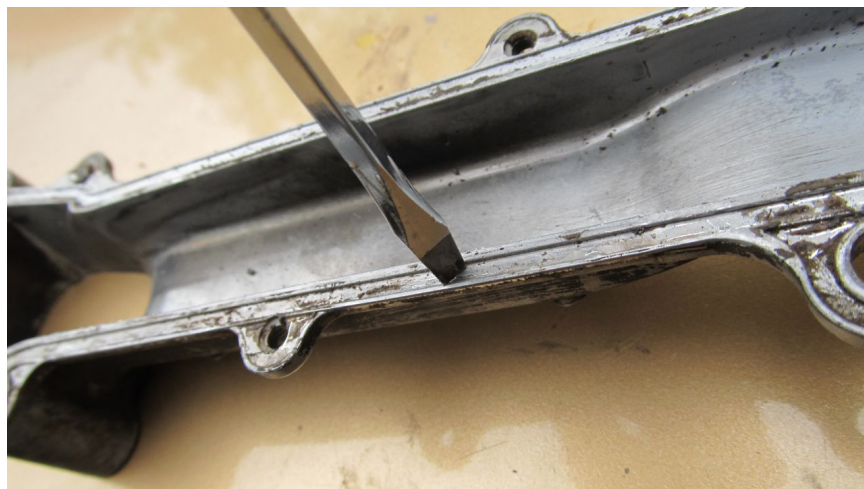
4. Carefully pry the two halves apart with a small thin screwdriver.
5. Use a small screwdriver and clean the old gasket material out of the groove.

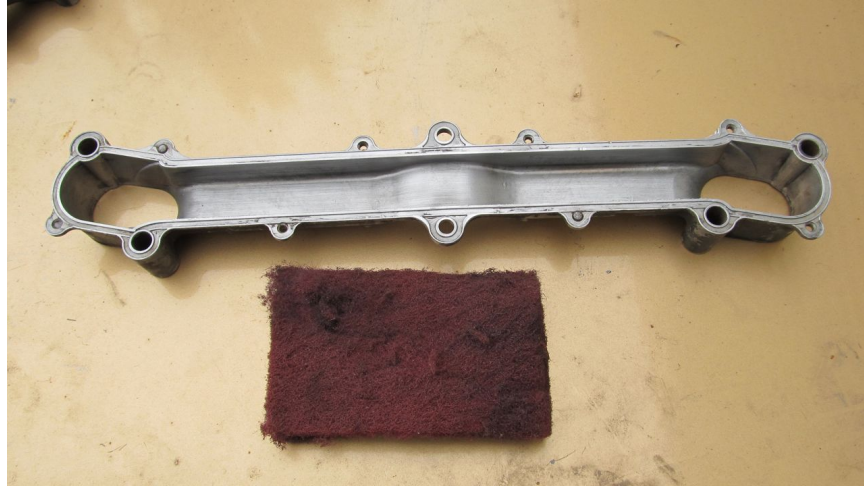
6. Use a Scotch Brite pad to clean the gasket mating surface.

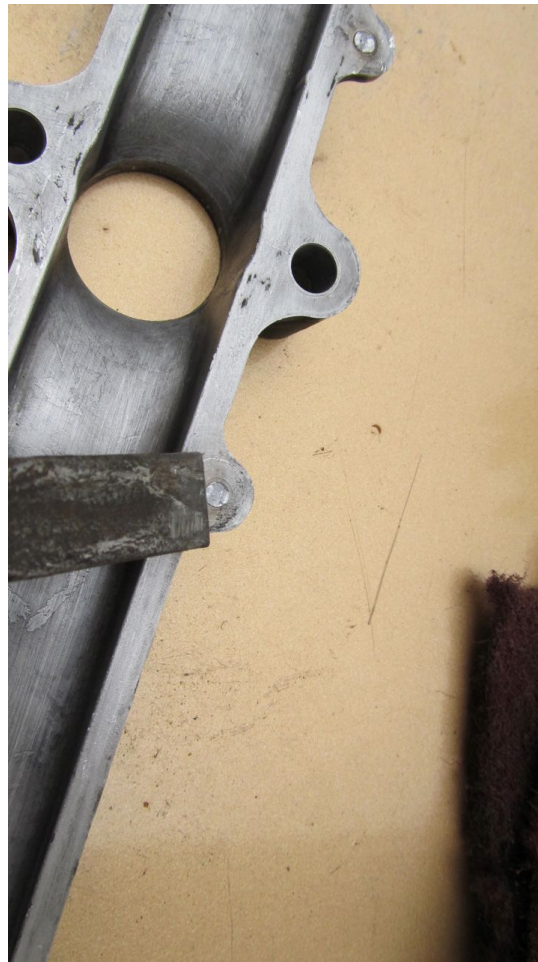
7. Using a small chisel, knock off the rivet stubs from the top half.

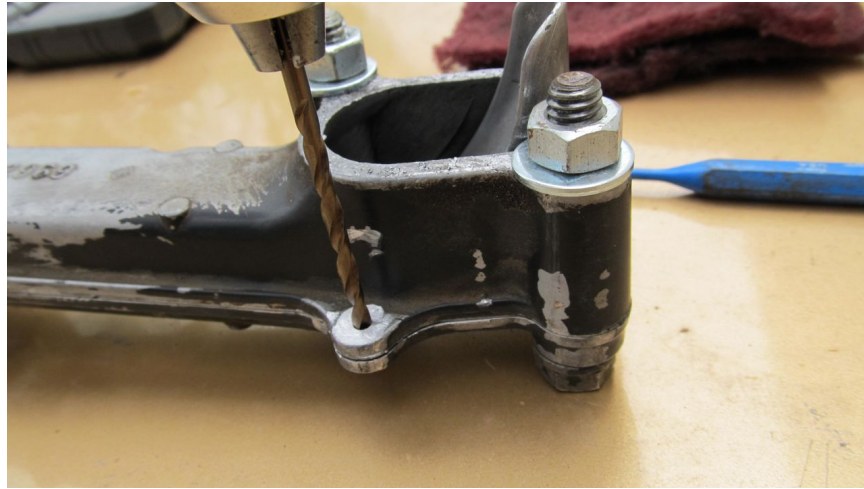
8. Bolt the two halves together using the mounting screws.

9. Drill out the upper half rivet boss with 1/8" drill using the lower hole as a guide.

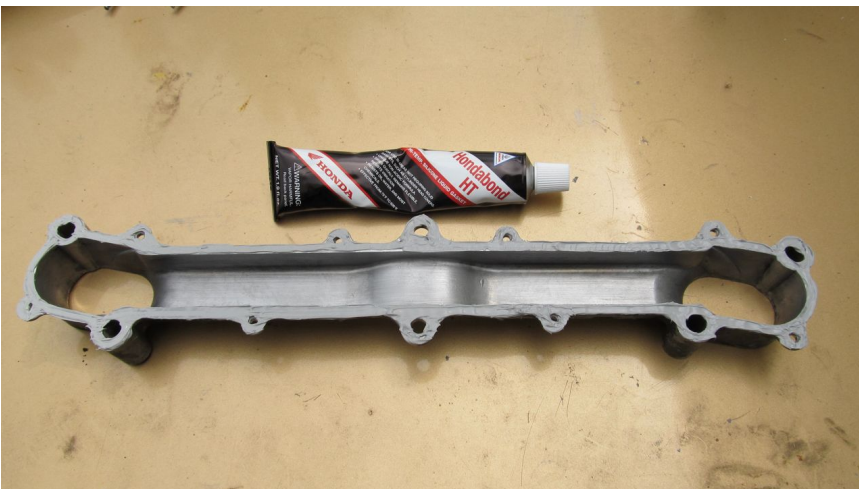
10. Using Hondabond HT, apply a thin bead of sealant to the mating groove.

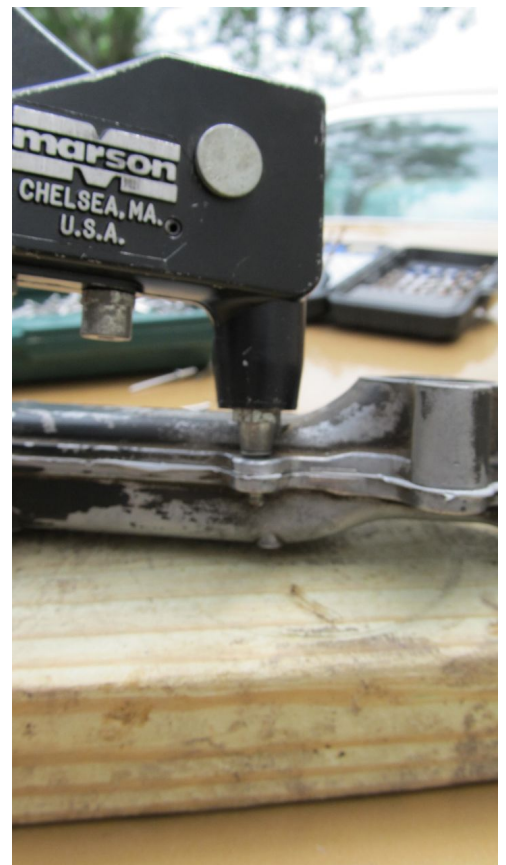
11. Rivet the two halves together using 1/8" rivets.

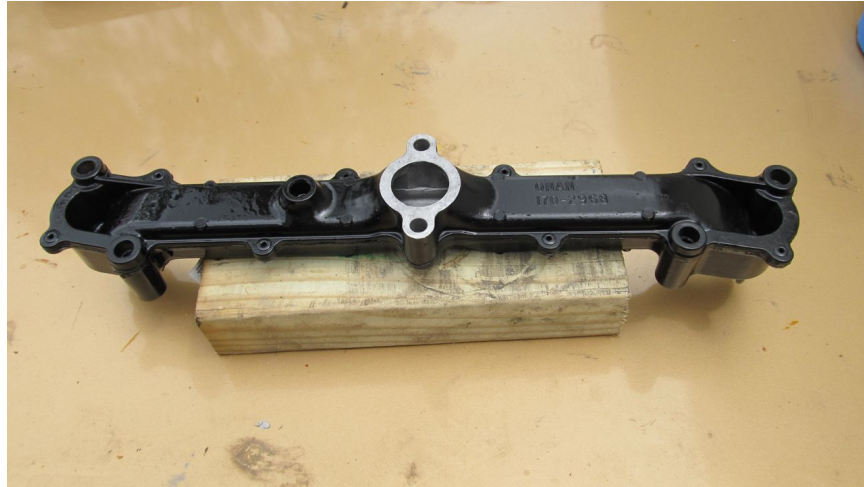
12. After allowing the sealant to dry, clean-up the edges, clean the intake and apply a fresh coat of paint.

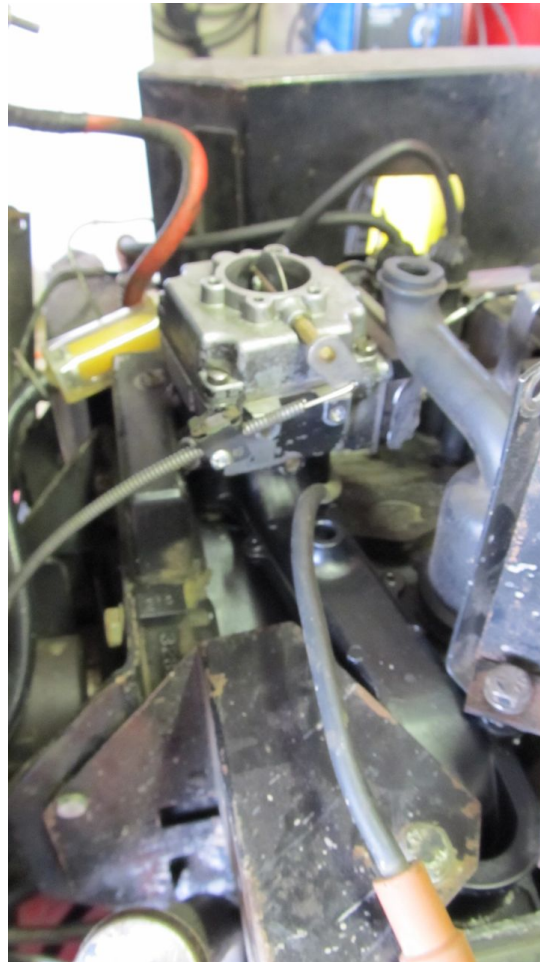
13. Re-install carburetor to intake manifold.
14. Re-install manifold to engine and torque mounting bolts to 6-10 ft-lbs.
