Ingersoll

TIMELY TIPS

1974 - 1979

Service Manual 9-51610

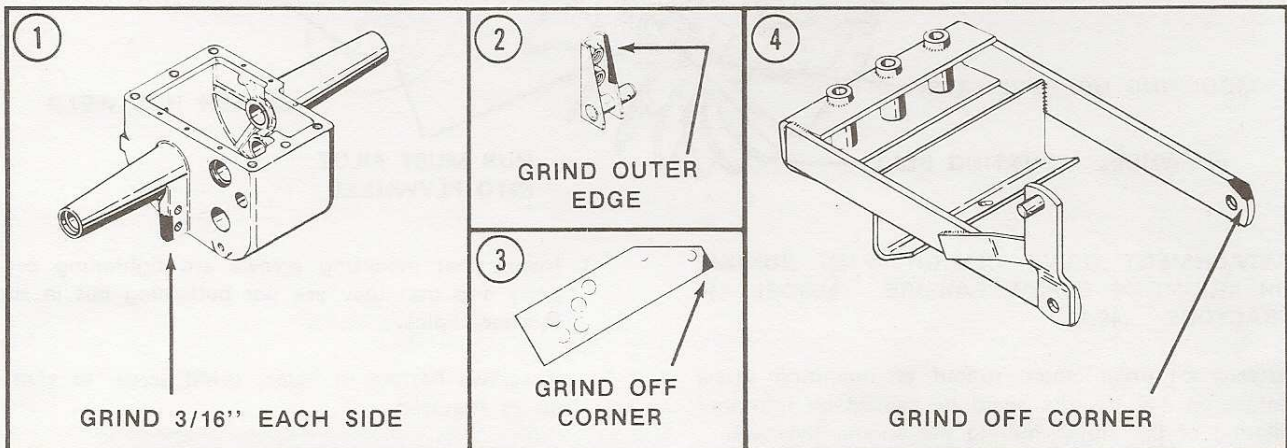
MODEL H22 AND H24 SLEEVE HITCH INTERFERENCE (12-4)

- A. There is a condition where the sleeve hitch arms can interfere with the transaxle housing mounting bosses on a limited number of recently produced 200 and 400 series compact tractors. Where this condition exists, there will also be inadequate clearance between the hydraulic drive motor and the axle housing for the L. H. hitch mounting bracket. These conditions are the result of a recently established second foundry source for the transaxle housing.

The potential interference points of both the lift lever plate and the H22 hitch arm have been relieved on all Sleeve Hitches shipped from the factory beginning the week of January 20, 1975.

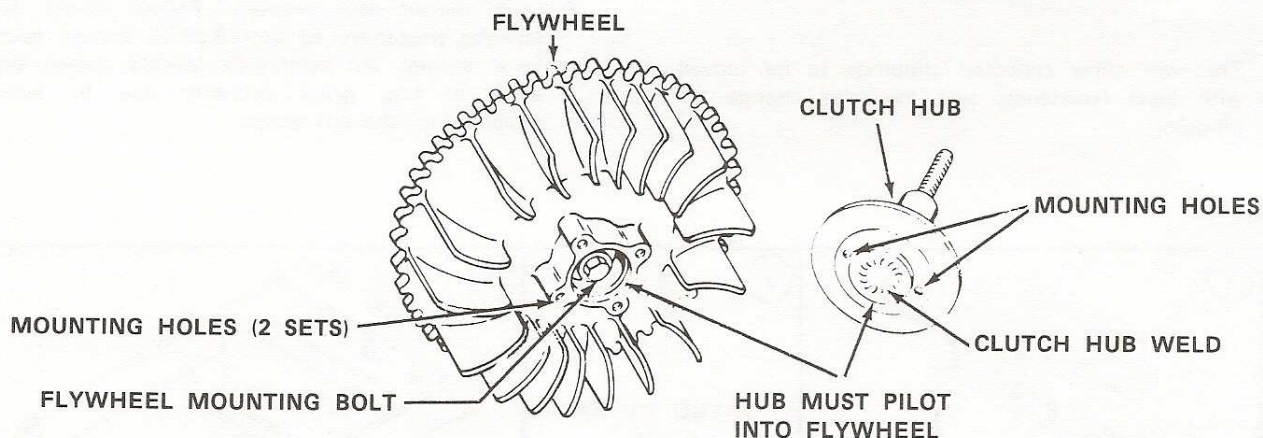
ATTACHMENT DRIVE CLUTCH (PTO) RUNOUT OR MOUNTING SCREW FAILURE - MODEL 446 TRACTORS (49-1)

Attachment drive clutch runout or mounting screw failure on 446 tractors could be caused by improper piloting of the clutch hub to the engine flywheel.

Check holes for alignment when holding clutch hub in position. If one set of mounting holes is out of alignment, check the second set. If both sets of mounting holes misalign with clutch hub, the flywheel must be replaced.

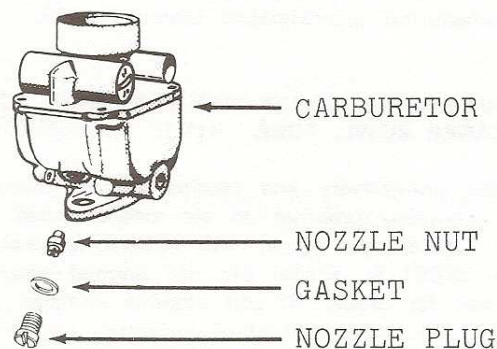
Hard starting as a result of carburetor bowl drainage has been reported on the Model 646 Loaders. The nozzle plug located on the lower rear area of the carburetor has been found to be loose allowing leakage. If the above symptom is encountered the plug should be checked and tightened if necessary. **See Illustration Below.**

All 646's - S/N 9732015 and after have been checked at the plant.

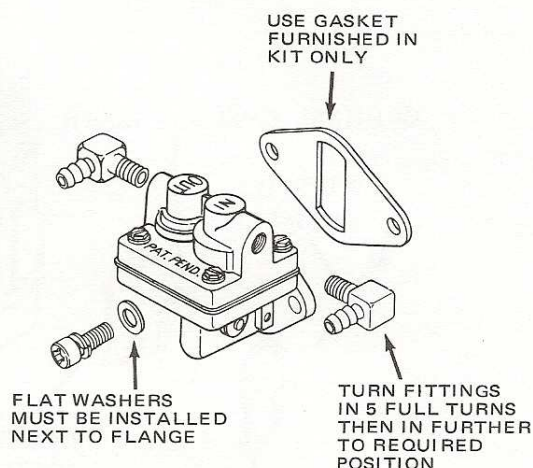
INSTALLATION PROCEDURE - PLASTIC BODY FUEL PUMPS FOR KOHLER ENGINE (41-3)

As a product improvement, plastic bodied fuel pumps are being installed on Kohler engines instead of the all metal pumps. The plastic pumps are interchangeable with the metal pumps. Plastic effectively insulates and prevents the fuel from vaporizing inside the pump.

NOTE: Check all engines in stock and all customer engines. Make sure the fittings are properly tightened if they have the plastic bodied fuel pumps.

2. Use **only** the gasket provided in the kit. If a thick insulating gasket was used with the metal pump, discard it. It is not only unnecessary but could cause distortion of the plastic flange while tightening the mounting screws.
3. Make sure the flat washers provided in the kits are installed next to the flange to prevent the lockwasher from damaging the plastic. The lockwashers and mounting screws from the old pump can be reused with the plastic pump but make sure the screws are tightened to **70 inch lbs. (7.8 Nm)** -- overtightening can damage the plastic flange.
