May 31, 1978

TIMELY OPE TIPS FOR THE MONTH

ISSUE # 51

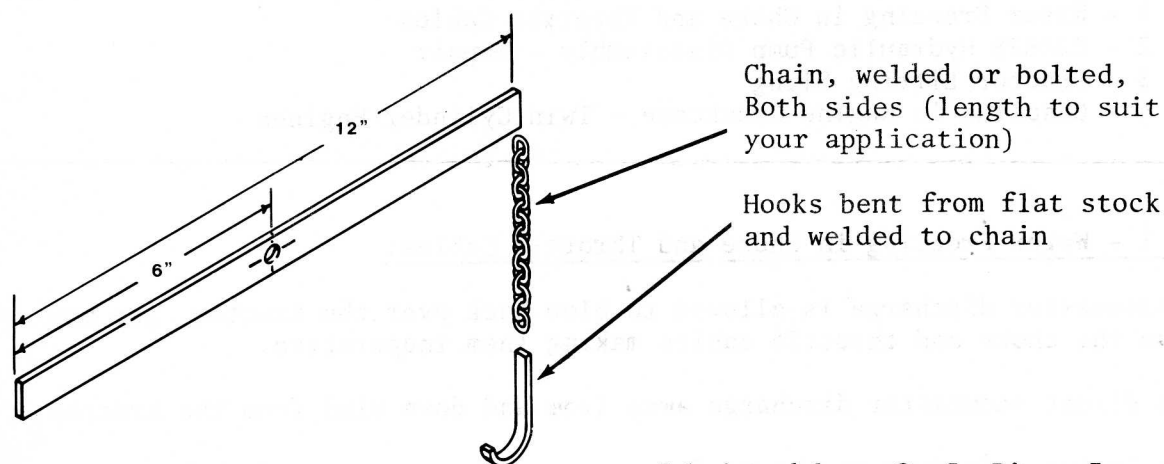
It is used during set up to lift tractor off skid and to hold tractor up while installing front spindles and rear wheels.

Be sure to use proper blocking and jackstands when working under the tractor.

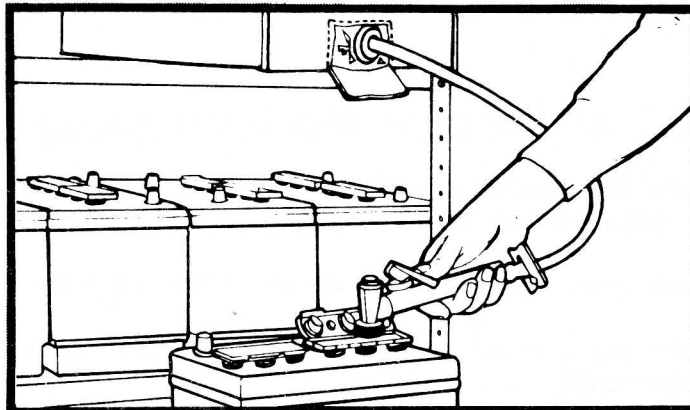
This one is the Thexton Activator, Part Number 604 Dry Charged Battery Filler, and costs approximately \$10.00. It is available from Thexton Manufacturing Company, Minneapolis, Minn., 56426.
