Gen III Front Drive System Differential Gearcase P/N 6203-01-256

Parts and Service Manual

Rev. 0 Released 11/12/2007

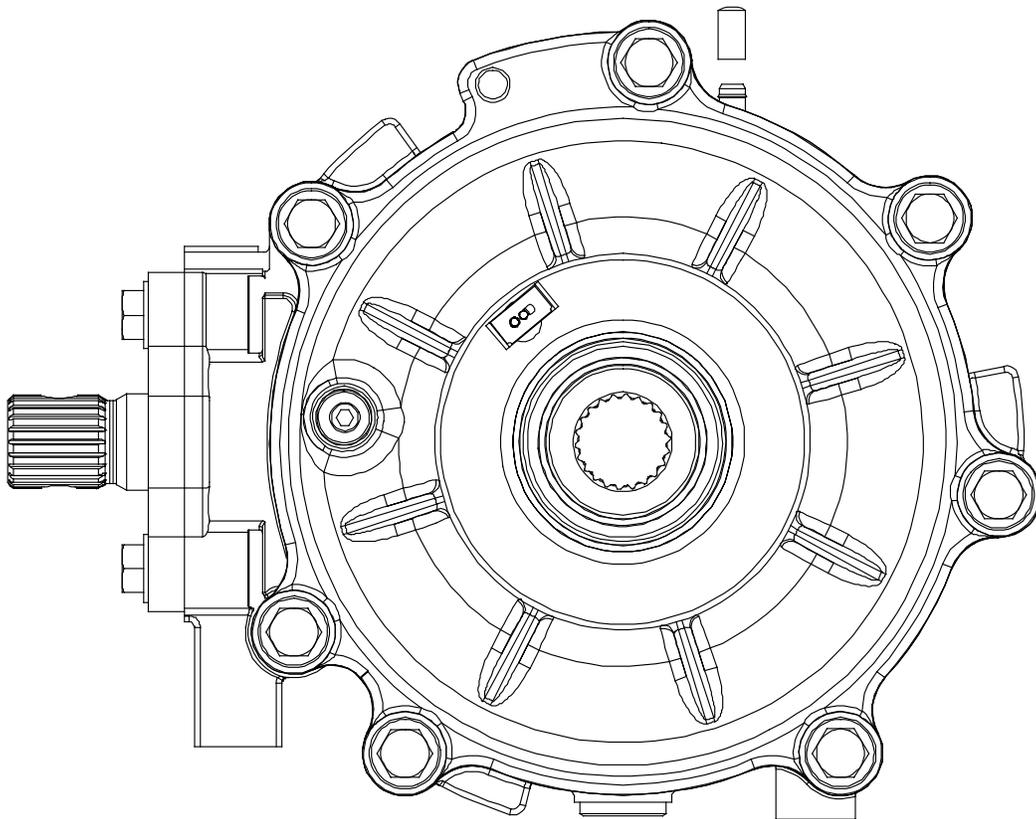
The Hilliard Front Drive System (Differential) is an electro-mechanically-activated bi-directional overrunning clutch. When 12 volts of power is sent to the 4WD switch, the unit is activated to engage both front wheels instantaneously, whenever the rear wheels lose traction. The clutch also releases or overruns automatically the instant the rear wheels regain traction. Because torque is transmitted to both front wheels, it is a “true” 4WD. The over-running characteristics of this system allow for an on demand 4WD engagement and steering ease.

Ratio.....	3.82:1 (Input:Output)
Fluid Capacity.....	150ml. (5 oz.) Hilliard CFD Gearcase Lube
Voltage.....	12 volts (15 volts max/11 volts min)
Coil Resistance.....	24.7 ohms to 27.3 ohms (at 20°C/68°F)
Input & Output Cover Bolt Torque.....	17 ft*lbs
Mounting Bolt Torque.....	32 ft*lbs.
Oil Fill Plug Torque.....	10 ft*lbs
Oil Drain Plug Torque.....	10 ft*lbs
External Input Shaft Spline.....	22 Tooth, 24/48 Pitch, Fillet Root Side Fit, Special Class 7
Internal Output Shaft Spline.....	22 Tooth, 24/48 Pitch, Fillet Root Side Fit, Special Class 7
Mounting Feet Thread Size.....	3/8-16 UNC-2B, (4) Places x .85” Deep
Continuous Torque Rating.....	145 ft*lbs (Input)
Hilliard 4WD CFD Gearcase Oil Part Number.....	0756-01-015-T

2. Check the resistance of the coil harness on the large output cover. This can be achieved by attaching a multi-meter to the (2) terminal pins (part #23 on the exploded view drawing located on page #5). The resistance should be 24.7 to 27.3 ohms (at 20°C/68°F). If the unit does not read any resistance, then there is a short in the coil & wire harness. The large Output Cover Sub-Assembly (P/N 6203-12-100) needs to be replaced. If the resistance in the coil is satisfactory, continue on to step # 3.

3. Check the armature plate (part #19) for a consistent wear pattern. To do this, completely drain the oil from the unit by removing the drain plug (part #32) located on the bottom of the gearcase with a 5/16" hex key wrench. Collect the oil and dispose properly. Remove the (7) hex head bolts (part #2) from the large cover using a 1/2" socket. Set the unit on a flat surface with the large output cover (part #27) facing up. Carefully lift the large cover straight up off of the gearcase. Remove the clutch housing/ring gear (part #12) out of the gearcase (be sure to hold the roll cage with the clutch housing/ring gear to prevent the cage from falling out). Remove the retaining ring (part #8) out of the large cover and then remove the nylatron (plastic) shim (part #40). Pick up the armature plate and wipe off any dirt or sludge. Inspect the surface that rides on the coil (part #26) located in the large output cover. There should be a consistent wear mark from the coil. Any interruptions in this wear pattern could indicate an out of flatness condition and the armature plate will need to be replaced (part #11). You can also check the flatness by setting the armature plate (tang facing up) on a flat surface or granite block and making sure the plate does not rock. If the armature plate wear is consistent and the plate is flat, continue on to step #4.

4. Check for the proper coil depth. The electro-magnetic coil (part #26) should set below the pole faces of the metal insert (steel u-shape piece pressed into the large cover assembly) located in the large output cover (part #27). To check this, simply run your fingers around the pole faces and make sure that the coil is correctly set below the metal insert along the entire circumference. If you feel the coil above the pole faces, replace the large output cover (P/N 6203-12-100). If the coil is fully below the pole faces, continue on to step #5.

5. Clean and inspect the internal clutch components. Slowly remove the roll cage (part #39) from the clutch housing/ring gear (part #12). Using a clean, dry, lint-free cloth, clean the (14) clutch rollers (part #38), the (2) race/output hubs (parts #16 & #17) and the internal profile in the clutch housing/ring gear (part #12). If there are any excessive scratches, nicks or deep flats present on any of these parts, replace with the proper service kit listed at the bottom of page 4:

1. Be sure that all parts are clean and free of any dirt or debris and all residual oil has been removed.
2. Check the condition of the square sectioned o-ring located on the large output cover (part #7). Make sure that it is clean and free of any cuts or nicks. It is recommended that this part is replaced whenever the unit is taken apart.

3. Place the thrust button (part # 41) back into the ½” hole located on the protruding boss on large cover plate (part #27). Place the thrust plate (part #13) on top of the same boss.

4. Press the race/output hub with the ½” male dowel pin (part #17) back into the large cover (part #27).
5. Set the armature plate (part #19) back onto the coil (part #26) located in the large cover plate (part #27). The tangs of the armature plate should face out from the cover.

6. Place the nylatron (plastic) shim plate (part #40) on top of the armature plate and install the retaining ring (part #8) back into the slot located on the large cover (part #27).

7. Insert the small needle roller bearing (part #6) onto the ½” dowel on the race/output hub.
8. Reassemble the clutch housing/ring gear (Part #12), the roll cage (part #39) and the (14) rollers (part #38).

9. Insert the assembled clutch from step #8 onto the large cover plate being sure to line up and insert the tangs from the armature plate (#19) into the mating slots on the roll cage (part #39). *It is very important to make sure the tangs on the armature plate are properly aligned into the slots on the roll cage or you will damage the armature plate and the 4WD will not work!*

10. Press the race/output hub with the ½” bushing (part #16) into the gearcase (part # 28).
11. Insert the gearcase (part #28) back onto the large cover plate assembly. Be sure the boltholes are lined up and the pinion gear (part #36) and the clutch housing/ring gear (part #12) mesh properly.

12. Torque the (7) 5/16-18 UNC-2A x 1” long hex head bolts (part #2) to 17 ft*lbs.
13. Be sure to clean off any dirt or debris on the drain plug (part #32). Using a 5/16” hex key wrench, reassemble the plug into the bottom of the gearcase torque to 10 ft*lbs.

14. Remove the oil fill plug (part #37) and fill the unit with 150 ml. (5 oz.) of the Hilliard 4WD CFD Gearcase oil.
15. Reassemble the oil fill plug (part #37) into the gearcase assembly (part #28) and torque to 10 ft*lbs.
